**ENVIRONMENTAL ASSESSMENT, TESTING AND ANALYSIS, INC.**  
**PO BOX 1557, CLINTON, MARYLAND 301-856-0340**

November 26, 2001

## U.S. Naval Communications Detachment - Cheltenham, Maryland

### Environmental Baseline Survey

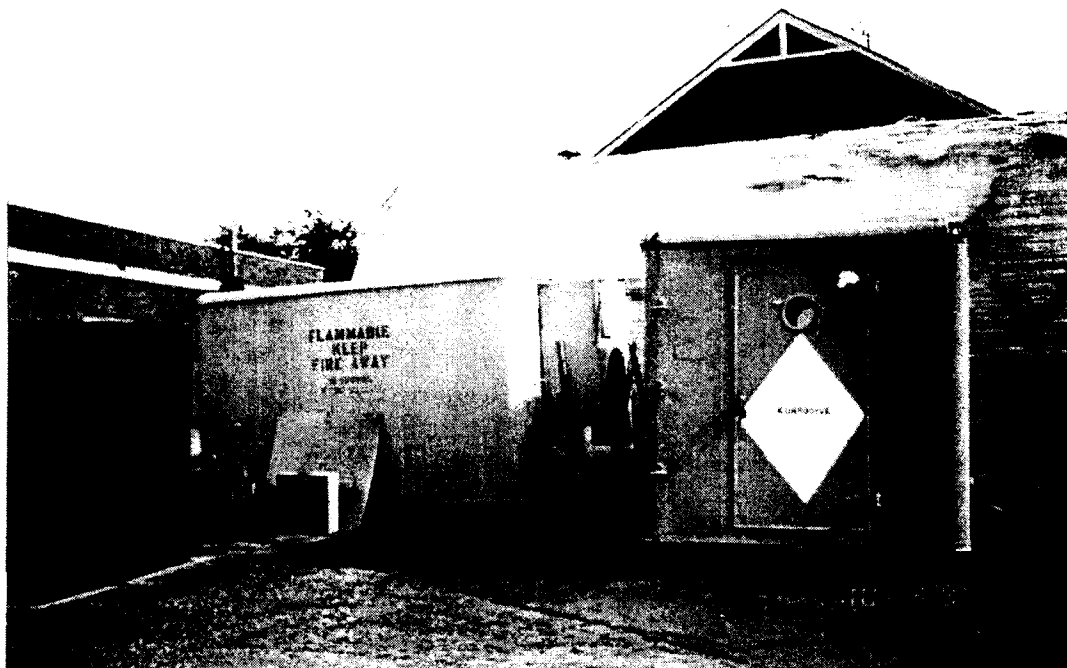
Flammable and corrosive storage trailers for Building 110 Public Works storage.

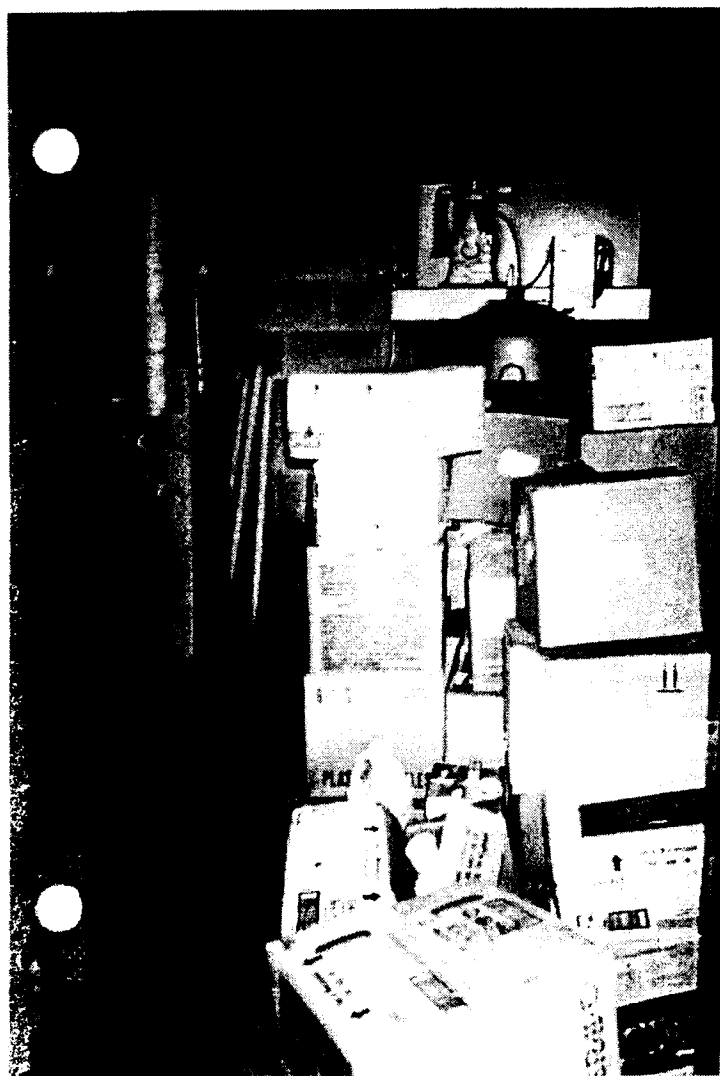
Cleaning chemical storage in Building 214. Some of the containers were damaged and leaking, including a box labeled corrosive.

- Remove and dispose of excess supplies and materials containing potentially hazardous substances (e.g., paints, cleaning compounds) and the items delineated "For Survey" in Building 14, in accordance with State and Federal regulations
- Remove and dispose of old equipment and appliances stored in Building 11 and in the courtyard, in accordance with State and Federal regulations

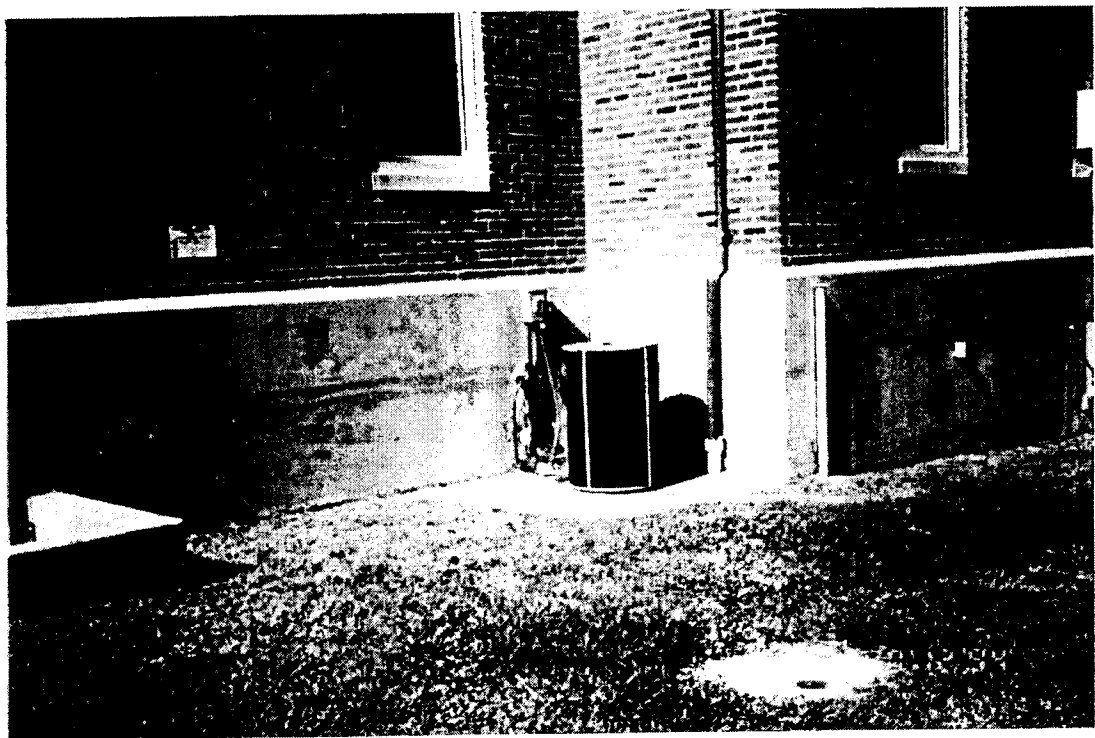
Number 2 diesel fuel UST at Building 13.

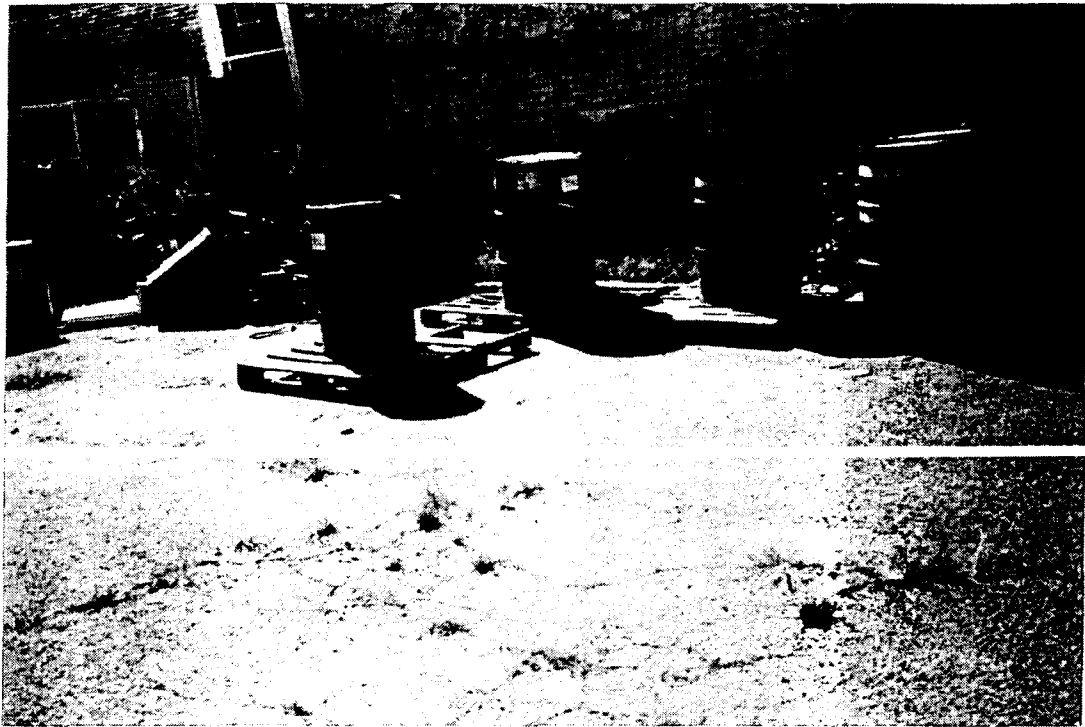
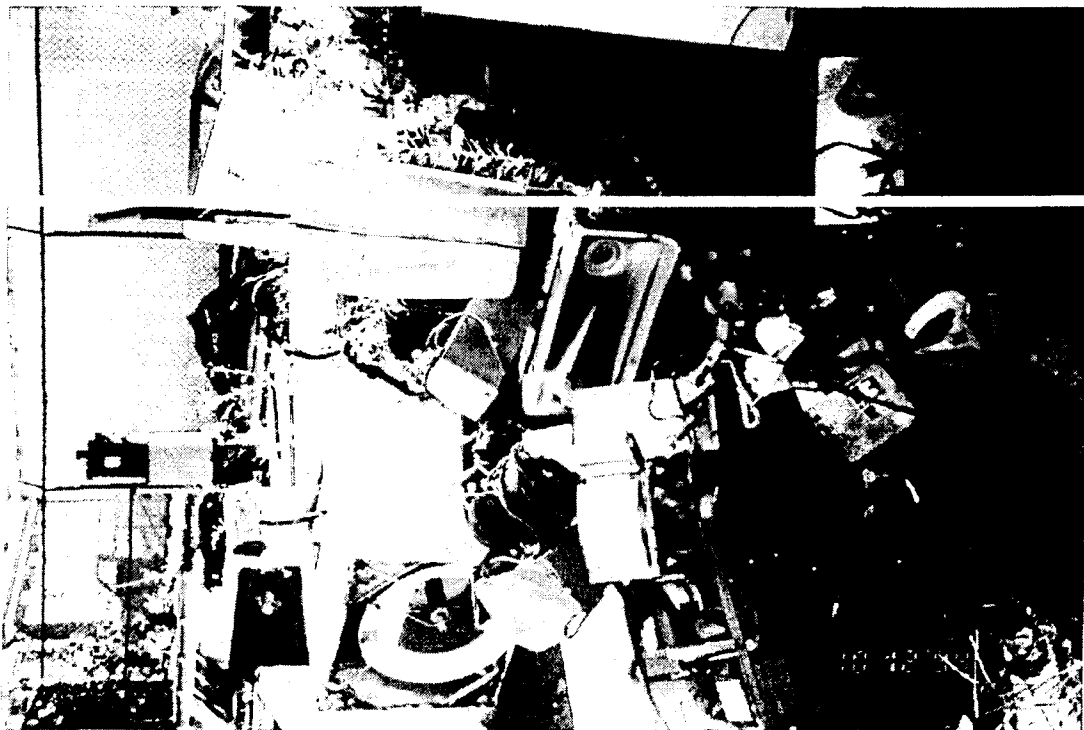
Both photos: storage area between Buildings 33 and 11, including various drums and appliances.

The courtyard is also used for storage of miscellaneous snow removal equipment; kitchen appliances such as washers, dishwashers, and stoves; air conditioners; sinks; two motor units; drinking fountains; and two refrigerators. A heat exchanger was also stored in the courtyard and exposed to the elements. A shelter located at Building 11 is also used to store lawn mowers, portable generators, electrical equipment, trash cans, two empty fuel oil aboveground storage tanks (ASTs), and a supply of metal casings used for electrical conduits. Equipment stored in these areas typically contains oils that could be contaminated with PCBs and several of the items may contain freon.

The front interior of Building 11 is used as dry storage for equipment such as furniture, bikes, playground benches, and a baseball field striper. The front of Building 11 is also used for the storage of old window air conditioning units manufactured in April 1979. Because of their age, these air conditioners may have contained freon.

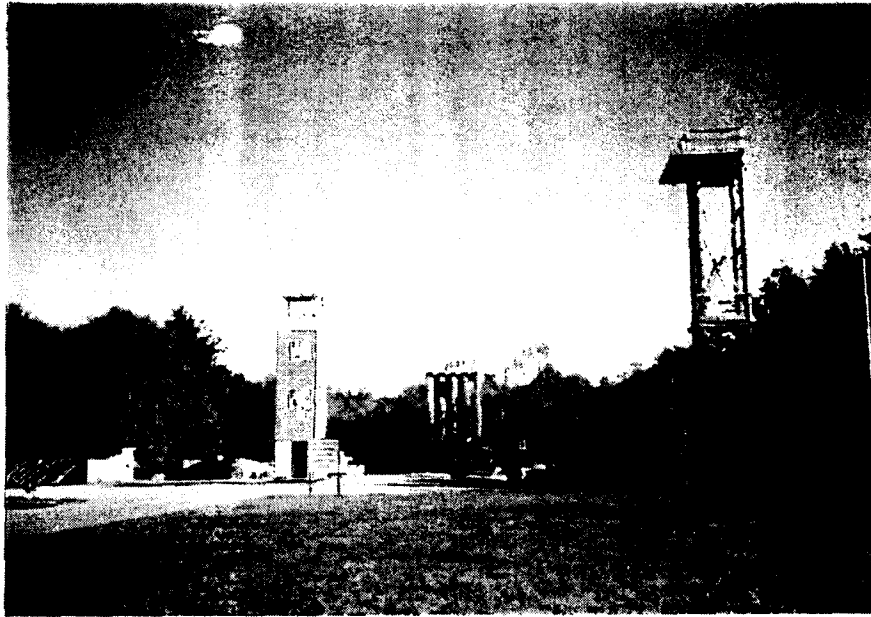
Building 41, currently part of the P.G. County Fire Training Academy. Storage for burn material for fire simulation area.

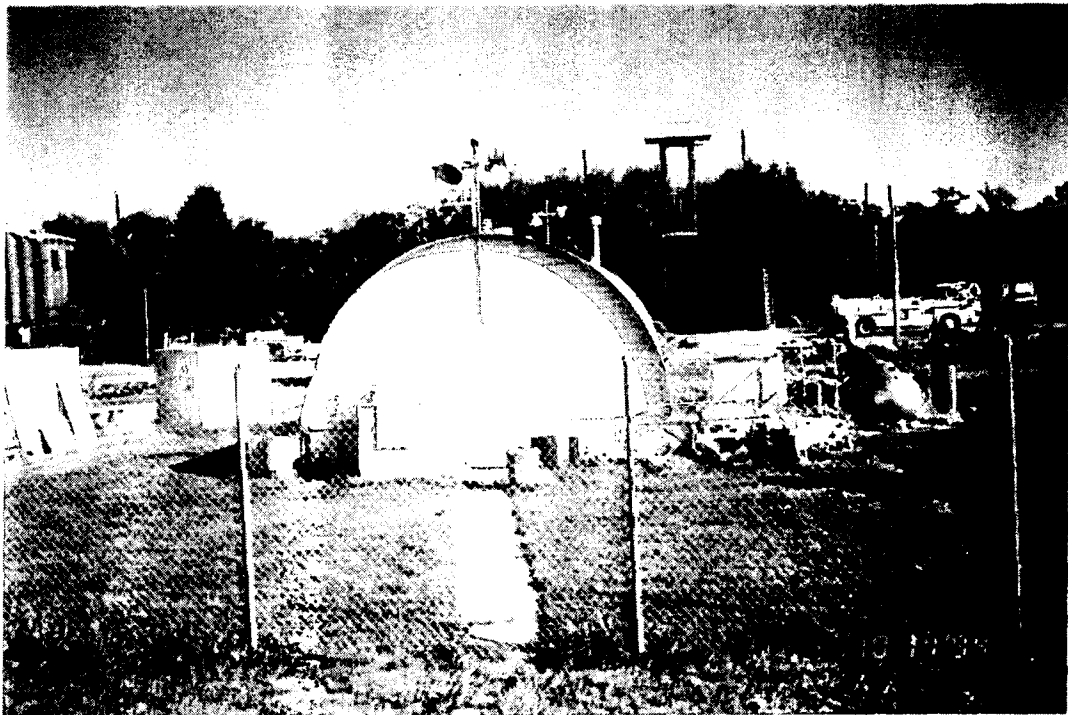
P.G. County Fire Training Academy fire simulation area.

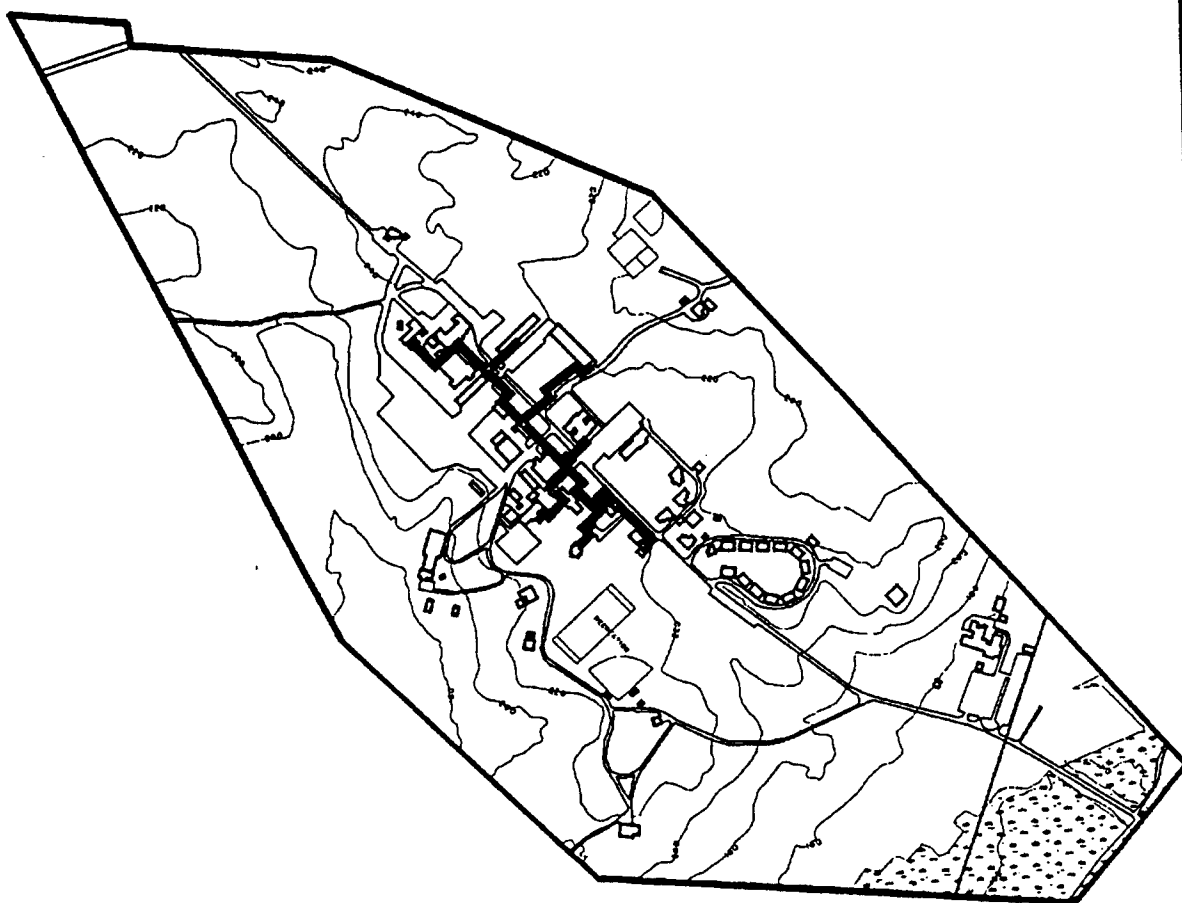
HIGH TEMPERATURE  
HOT WATER LINES

**Heat** - Heat is provided to the majority of NCDC core base buildings along Redman Avenue via high temperature hot water (HTHW) lines which originate at the installation's central heating plant located in Building 2. There are two main HTHW distribution lines; one HTHW line runs north of the central heating plant and the other HTHW line runs south. Figure 4-2 delineates the subgrade HTHW lines located at NCDC. Tables 2-1, 2-2, and 2-3 list the buildings and structures and their corresponding heating systems, if applicable.

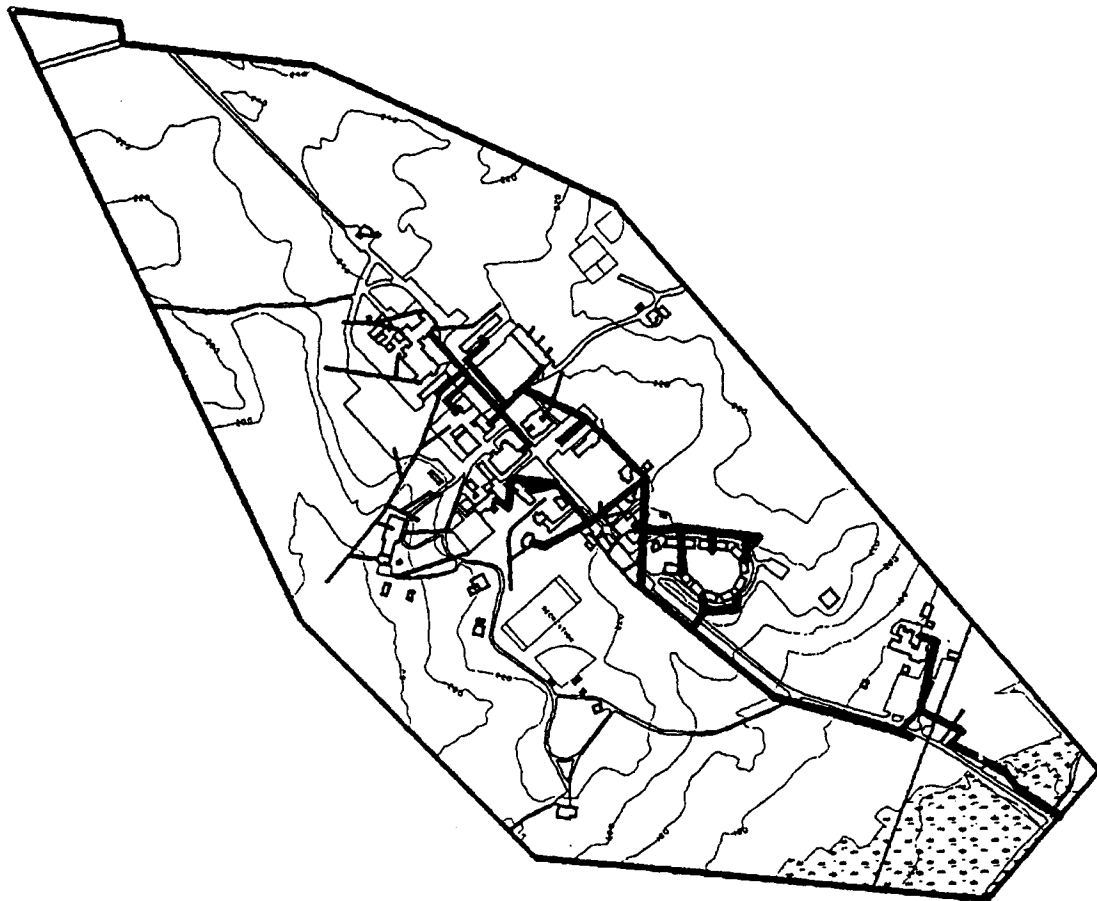
MAJOR SANITARY  
SEWER LINES

**Sanitary Sewer** - According to NCDC's Master Plan Update, the sanitary sewer system consists of approximately 7,200 linear feet of gravity sewer line, 1,600 feet of force mains, and two lift stations. The primary sanitary sewer line runs northwest to southeast along Redman Avenue and branches off to service the operations and housing facilities along the core base. Figure 4-5 delineates the main sanitary sewer lines at NCDC.

The sewer lines are in excess of 40 years old according to NCDC's Master Plan Update. A television inspection conducted in 1983 revealed deficiencies in the lines, including offset joints, root intrusions, broken and crushed pipe, mineral deposit dips, and cracks and it was concluded in the above-referenced document that the vertical misalignments and structural deteriorations are probable sources of infiltration and blockages.
